## Pre Purchase Condition Survey (PPC)

**Inspect on the** 2011  
**the** Fairline 43  
**at** Norfolk  
**Purpose** Pre Purchase Condition Survey  
**Report ref** # 00000-11

### A1 Vessel Particulars

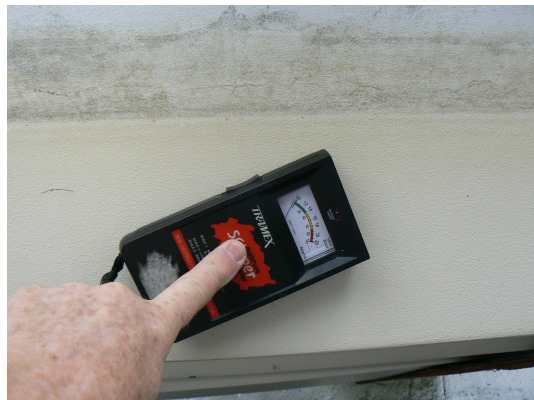
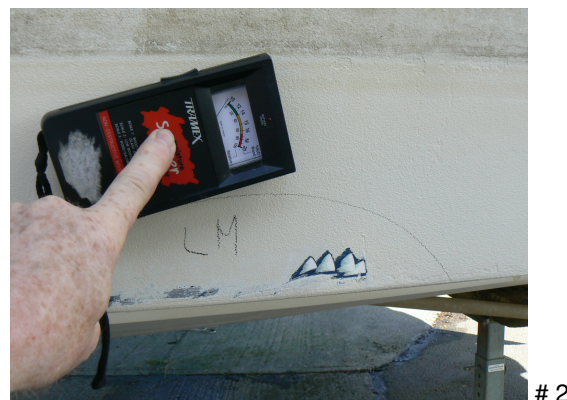
In sample areas (gelcoat) moisture meter readings were taken and returned relatively low readings < 10%. (green scale) indicating that the underlying substrate is relatively low in moisture content. This meter reading translates to a moisture content in the GRP substrate sample areas of < 1.0 % For guidance purposes 'acceptable moisture levels' in a used boat are of the order of < 1.8 % (approx)

# 1 & 2 Low moisture meter readings

- General maintenance

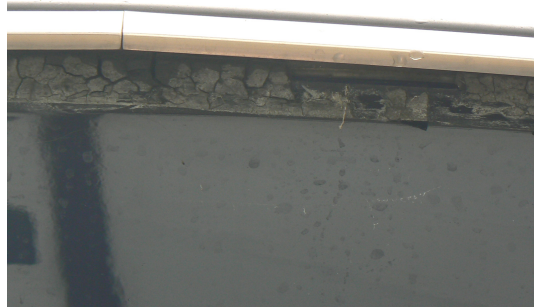
The hull / superstructure deck joint packing shows evidence of overall degradation consistent with age

# 1 Gunwale packing degradation

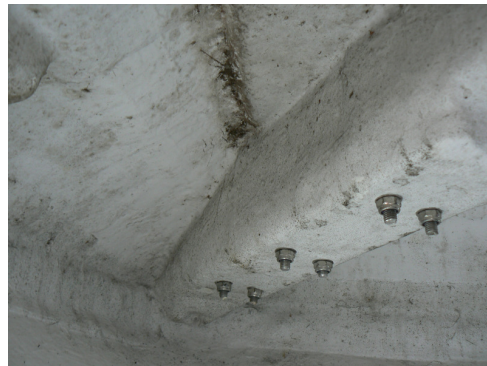
Hull / superstructure connection – Through bolted / riveted and encapsulated / bonded throughout

# 2 Hull deck bonding

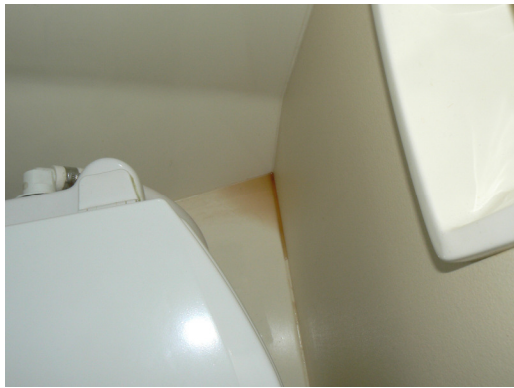
There was evidence of water ingress / staining from the starboard toilet / shower unit portlight

# 1 Staining / water suspected to be from 'leaking' starboard toilet portlight

- Investigate leaks and re-seal starboard toilet portlight as found necessary

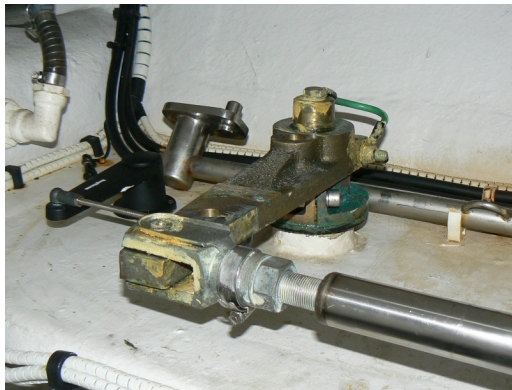
# 1 Steering arm / Tie bar connections

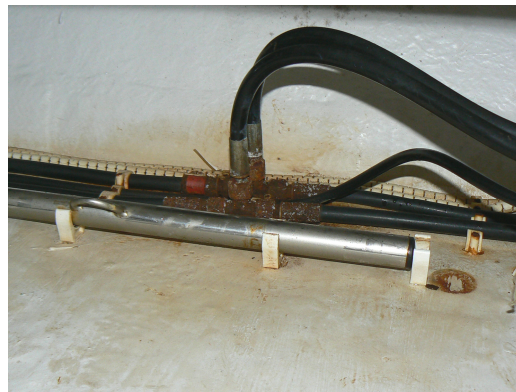
<b>Steering:</b>	Hydraulic	<b>Condition:</b>	OK
<b>Hydraulic system:</b>	Unions displayed evidence of corrosion – renew during maintenance		
<b>Steering arms:</b>	Bronze	<b>Condition:</b>	OK
<b>Connections:</b>	Bolts	<b>Condition:</b>	OK
<b>Tie Bar</b>	Torsion tube	<b>Condition:</b>	OK
<b>Emergency Steering:</b>	Yes		
<b>Rudder tube / gland:</b>	Bronze	<b>Condition:</b>	OK
<b>Rudder tube bearings:</b>	NV	<b>Condition:</b>	
<b>Greaser:</b>	No	<b>Condition:</b>	
<b>Rudder(s)</b>	2x Hanging spade	<b>Condition:</b>	Good
<b>Earth Bonding:</b>	Yes

# 2 Corroded hydraulic unions

- Replace corroded hydraulic steering HP unions during general servicing

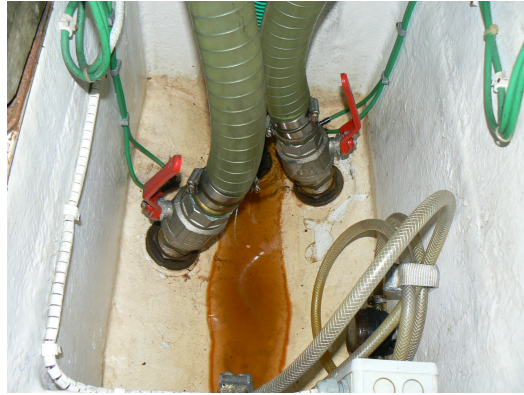
# 1 Engine sea cocks

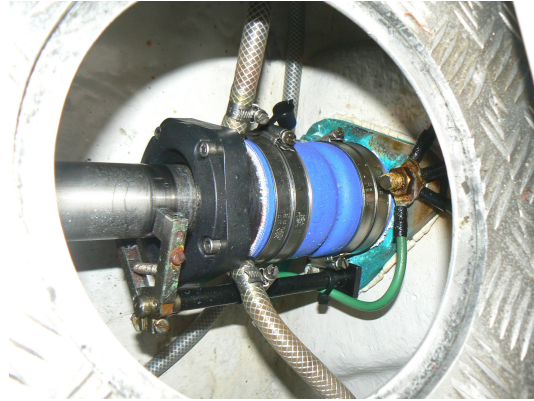
**Comments:** Minor electrolytic corrosion on stern tube flange

# 2 Deep Sea Seal gland with cooling water – Note minor electrolytic corrosion on flange

- General maintenance

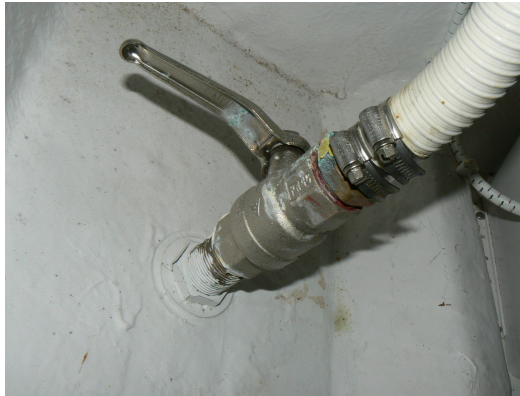
- # 1 Ball valve seacock in fwd bilges
- # 2 Bilge system valve assembly

- General maintenance

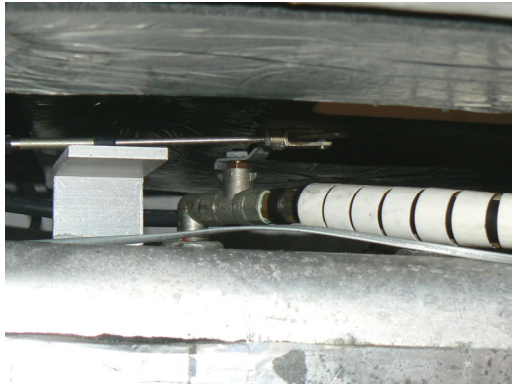
# 1 Fuel supply isolation valve – limited access to tank tops

- Refer to attached Appendix A for recommendations

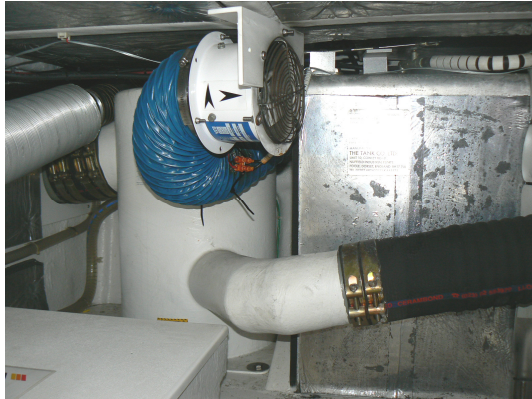
# 1 Exhaust system with marine silencer – Note engine room blower

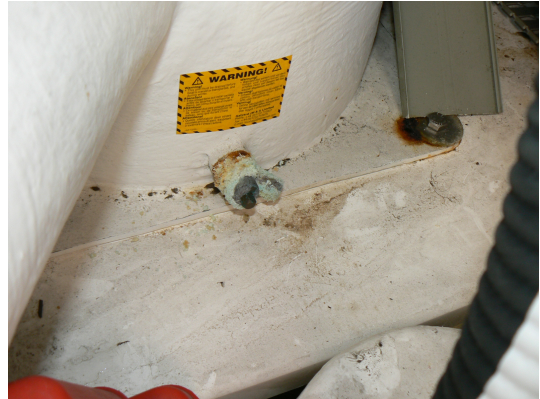
Limited corrosion on silencer drain tap

# 2 Limited corrosion on silencer drain outlet

- General maintenance
